**Flood Control Project Maintenance
Levee Inspections**
LMA District Cover Sheet
Spring 2019 Levee Inspection Results

Reclamation District No. 0349 Sutter Island

Spring 2019 Levee Inspection Results

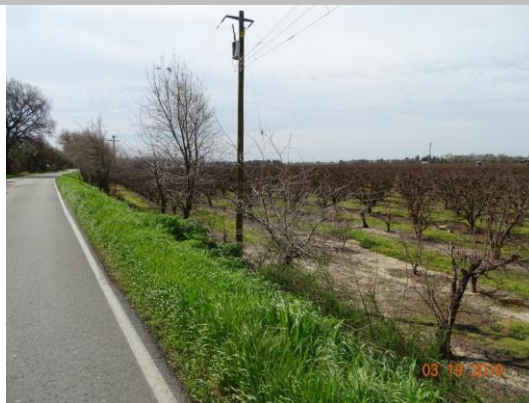
Photo 1 of 1 : SP_2019_RD0349_204_11_20190320_00030.jpg

LM Start	0.03	Rating **	M	Issue No.	11
LM End	1.45	Issue Type +	Ma	Location *	LS
Category	Earthen Levee			GPS Latitude/Longitude	
				Start	End
Item	Vegetation			38.326842 °	38.306995 °
				-121.577010 °	-121.575432 °
DWR ID	DWR_RD0349_01_s_2019_11				
Comment Code					
V1 : Control annual grass and weeds on the levee slopes and easements.					
Inspector Comment

View looking downstream at annual vegetation on the landside slope (Spring 2019).

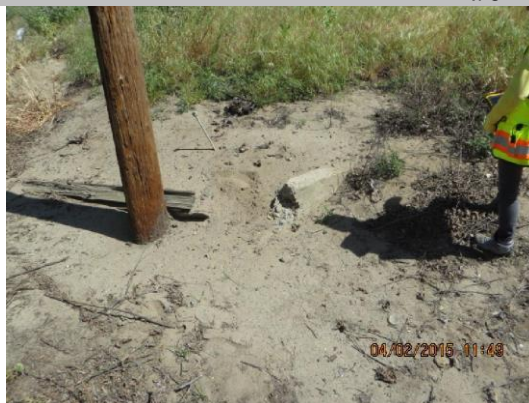
Photo 1 of 3 : UCIP_SP_2019_44303_73622.jpg

Comment Code						
Inspector Comment						
FS_ID:44303						
DS_ID:24137						
EP_NO: N/A						
Repair Type: Non-Urgent						
Crossing Status: Indicator Found						
UCIP Comments: Pipe appears to be abandoned and if so should be done so properly. Electromagnetic survey indicated a crossing at this location.						
FIELD_STRUCT_DESC: *ABANDONED* 10-inch irrigation pipe of unknown material through the levee, 3.8 feet below the levee crown. Power pole and anchor on the landside (LS). Deteriorated concrete box at the LS toe. Concrete debris on the waterside (WS) toe good indicator of pump location. [Additional Reference(s): DWR Levee Log, 2005. USACE Sacramento O&M Manual Unit No. 110, May 1959, revised 29 Dec 2016, (HLM 0.1)]						
FS Date: 4/2/2015

Deteriated concrete distribution box on LS toe next to power pole.

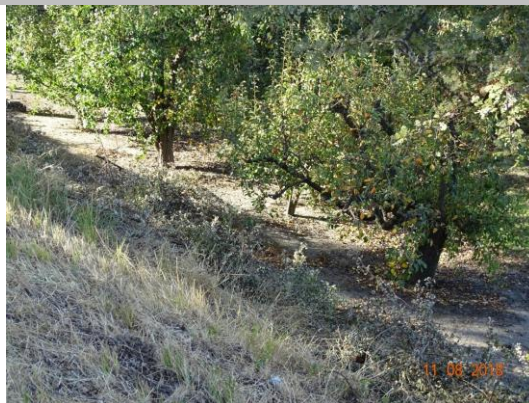
Photo 1 of 1 : SP_2019_RD0349_204_17_20190311_00004.jpg

LM Start	0.14	Rating **	M	Issue No.	17
LM End	0.14	Issue Type +	En	Location *	LS
Category	Earthen Levee			GPS Latitude/Longitude	
				Start	End
Item	Encroachments			38.325248 °	38.325248 °
				-121.577478 °	-121.577478 °
DWR ID	DWR_RD0349_01_f_2018_17				
Comment Code					
CR : Crops					
Inspector Comment					
Orchard trees are encroaching on the landside toe.

View of orchard trees encroaching on the landside toe (November 2018).

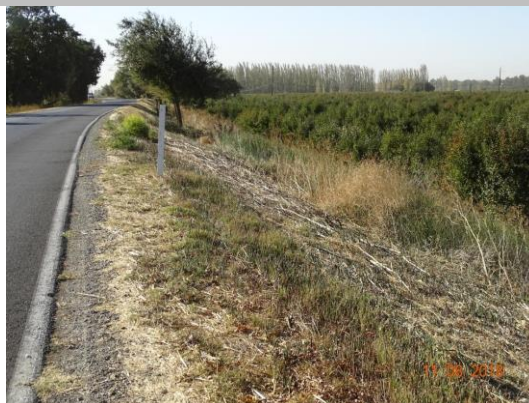
Photo 1 of 1 : SP_2019_RD0349_204_21_20190311_00005.jpg

LM Start	0.22	Rating **	M	Issue No.	21
LM End	0.26	Issue Type +	Ma	Location *	LS
Category	Earthen Levee			GPS Latitude/Longitude	
				Start	End
Item	Vegetation			38.324052 °	38.323492 °
				-121.577778 °	-121.577952 °
DWR ID	DWR_RD0349_01_f_2018_21				
Comment Code					
V1 : Control annual grass and weeds on the levee slopes and easements.					
Inspector Comment					
Remove vegetation all the way down to the landside toe.

Vegetation looking downstream on the landside slope (November 2018).

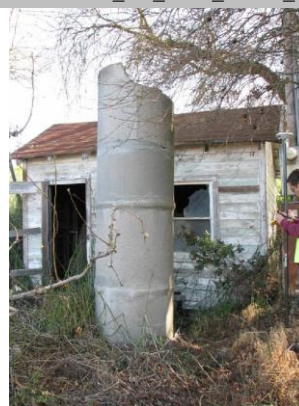
Photo 3 of 3 : UCIP_SP_2019_21572_36578.jpg

Comment Code						
Inspector Comment						
FS_ID:21572 DS_ID:24521 EP_NO: N/A Repair Type: Non-Urgent Crossing Status: Found UCIP Comments: No records were found during intial desk study--need to contact owner to obtain permit number authorizing work. If crossing is no longer used by owner, the owner will need to coordinate with DWR Inspector and CVFPB to remove crossing according to Title 23 requirements. Dense vegetation limits the inspector's visibility to identify signs of pipe failure (leaks) along the slope. Recommend removing vegetation along pipe alignment to conduct proper inspection of structure and appurtenances. Note date on photos should be 3/18/09 not 7/26/08 camera metadata is incorrect. FIELD_STRUCT_DESC: *ABANDONED* 8-inch irrigation pipe of unknown material through the levee, 13.9 feet below the levee crown. Pump on platform at landside (LS) toe. Service pole on LS slope. FS Date: 3/18/2009

View of pump house, concrete stand pipe, and utility pole.

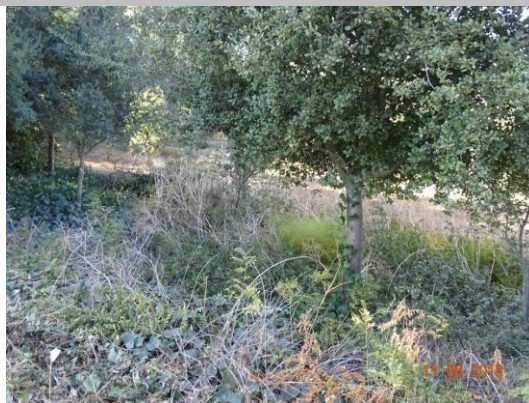
Photo 1 of 1 : SP_2019_RD0349_204_35_20190311_00010.jpg

LM Start	0.97	Rating **	U	Issue No.	35
LM End	0.97	Issue Type +	Ma	Location *	LS
Category	Earthen Levee			GPS Latitude/Longitude	
				Start	End
Item	Vegetation			38.313380 °	38.313380 °
				-121.578860 °	-121.578860 °
DWR ID	DWR_RD0349_01_f_2018_35				
Comment Code					
V2 : Remove the wild growth other than native grasses from the levee slopes.					
Inspector Comment					
Remove vegetation from the landside toe.

View of vegetation on the landside toe (November 2018).

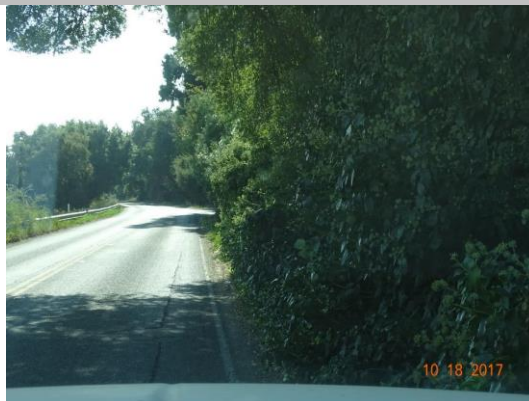
Photo 1 of 1 : SP_2019_RD0349_204_27_20190311_00006.jpg

LM Start	0.98	Rating **	U	Issue No.	27
LM End	1.10	Issue Type +	En	Location *	LS
Category	Earthen Levee			GPS Latitude/Longitude	
				Start	End
Item	Vegetation			38.313200 °	38.311493 °
				-121.578797 °	-121.578257 °
DWR ID	DWR_RD0349_01_f_2017_27				
Comment Code					
V6 : Landscaping					
Inspector Comment					
Landside landscaping must be removed or trimmed to allow inspection and access.

View of landside landscaping

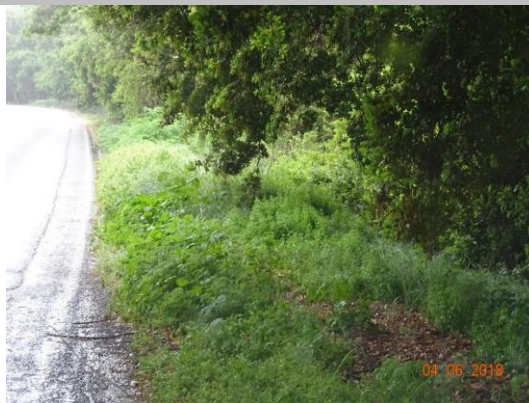
Photo 1 of 1 : SP_2019_RD0349_204_29_20190311_00007.jpg

LM Start	1.20	Rating **	M	Issue No.	29
LM End	1.21	Issue Type +	Ma	Location *	LS
Category	Earthen Levee			GPS Latitude/Longitude	
				Start	End
Item	Vegetation			38.310110 °	38.309955 °
				-121.577608 °	-121.577495 °
DWR ID	DWR_RD0349_01_f_2017_29				
Comment Code					
V2 : Remove the wild growth other than native grasses from the levee slopes.					
Inspector Comment

Manage landside vegetation to allow inspection and access.

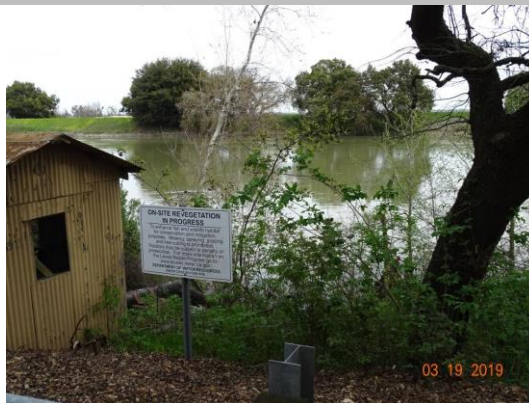
Photo 1 of 1 : SP_2019_RD0349_204_18_20190320_00032.jpg

LM Start	1.40	Rating **	A/W	Issue No.	18
LM End	1.40	Issue Type +	Ob	Location *	WS
Category	Earthen Levee			GPS Latitude/Longitude	
				Start	End
Item	Vegetation			38.307657 °	38.307657 °
				-121.575890 °	-121.575890 °
DWR ID	DWR_RD0349_01_s_2019_18				
Comment Code					
V8 : Environmental Requirements.					
Inspector Comment					
Revegetation site

View of revegetation sign on the waterside shoulder (Spring 2019).

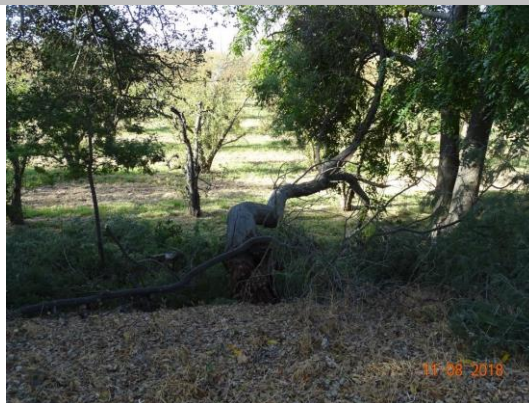
Photo 1 of 1 : SP_2019_RD0349_204_36_20190311_00011.jpg

LM Start	1.40	Rating **	M	Issue No.	36	
LM End	1.40	Issue Type +	Ma	Location *	LS	
Category	Earthen Levee			GPS Latitude/Longitude		
				Start		End
Item	Encroachments			38.307553 °	38.307553 °	
				-121.575848 °	-121.575848 °	
DWR ID	DWR_RD0349_01_f_2018_36					
Comment Code						
TR : Tree or limb						
Inspector Comment

View of fallen tree limb on the landside toe (November 2018).

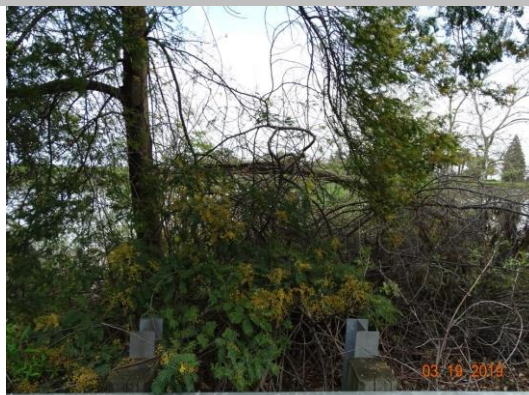
Photo 1 of 1 : SP_2019_RD0349_204_16_20190320_00031.jpg

LM Start	1.45	Rating **	U	Issue No.	16
LM End	1.45	Issue Type +	Ma	Location *	WS
Category	Earthen Levee			GPS Latitude/Longitude	
				Start	End
Item	Trim / Thin Trees			38.306995 °	38.306995 °
				-121.575432 °	-121.575432 °
DWR ID	DWR_RD0349_01_s_2019_16				
Comment Code					
T1 : Trim trees to at least five feet above ground level.					
Inspector Comment

View of thick trees on the waterside slope (Spring 2019).

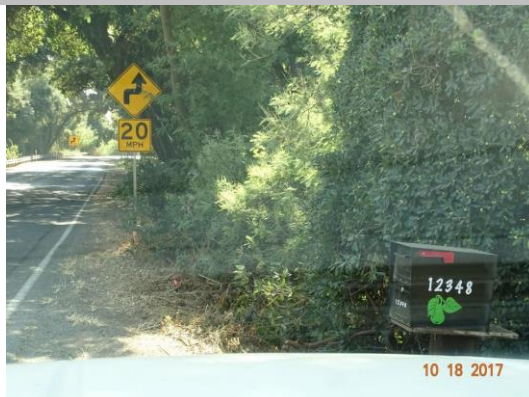
Photo 1 of 1 : SP_2019_RD0349_204_33_20190311_00008.jpg

LM Start	1.45	Rating **	M	Issue No.	33
LM End	1.45	Issue Type +	En	Location *	LS
Category	Earthen Levee			GPS Latitude/Longitude	
				Start	End
Item	Vegetation			38.306919 °	38.306919 °
				-121.575473 °	-121.575473 °
DWR ID	DWR_RD0349_01_f_2017_33				
Comment Code					
V6 : Landscaping					
Inspector Comment					
Landside landscaping should be thinned and maintained to allow inspection and access to levee slope and toe.

View of landside landscaping on the levee slope and toe

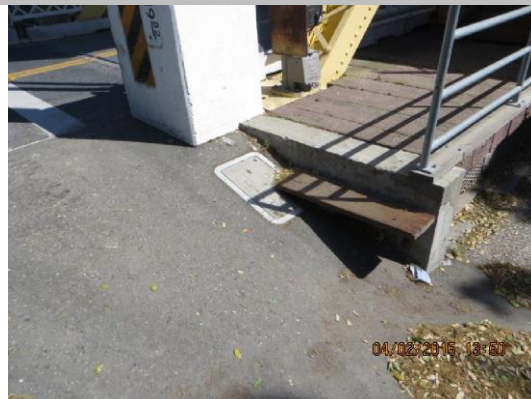
Photo 2 of 3 : UCIP_SP_2019_46168_74543.jpg

LM Start	0.00	Rating **	M	Issue No.	105
LM End	0.00	Issue Type +	En	Location *	
Category	Supplemental			GPS Latitude/Longitude	
				Start	End
Item	DWR UCIP Field Study			38.305124 °	38.305124 °
				-121.574772 °	-121.574772 °
DWR ID	25096				
Comment Code					
Inspector Comment					
FS_ID:46168 DS_ID:25096 EP_NO: N/A Repair Type: Non-Urgent Crossing Status: Indicator Found UCIP Comments: Need to identify permit for crossing. FIELD_STRUCT_DESC: 2-inch waterline through the levee at an unknown depth below crown. Pipe provides service to bridge and beach (per landowner). FS Date: 4/9/2015

Christy box on WS shoulder.

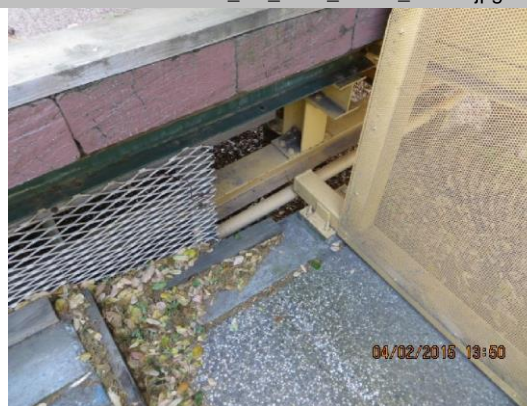
Photo 3 of 3 : UCIP_SP_2019_46168_74544.jpg

LM Start	0.00	Rating **	M	Issue No.	105 (cont)	
LM End	0.00	Issue Type +	En	Location *		
Category	Supplemental			GPS Latitude/Longitude		
				Start		End
Item	DWR UCIP Field Study			38.305124 °		38.305124 °
				-121.574772 °		-121.574772 °
DWR ID	25096					
Comment Code						
Inspector Comment						
FS_ID:46168						
DS_ID:25096						
EP_NO: N/A						
Repair Type: Non-Urgent						
Crossing Status: Indicator Found						
UCIP Comments: Need to identify permit for crossing.						
FIELD_STRUCT_DESC: 2-inch waterline through the levee at an unknown depth below crown. Pipe provides service to bridge and beach (per landowner).						
FS Date: 4/9/2015

Pipe visible next to bridge on WS shoulder.

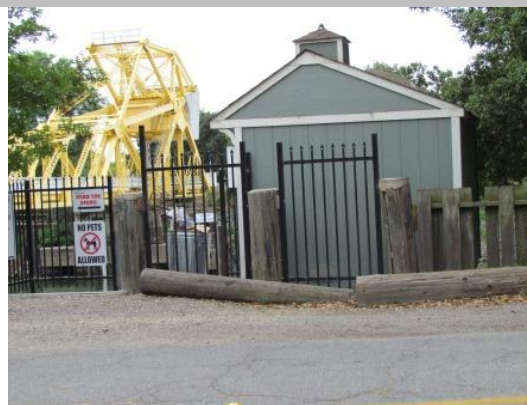
Photo 1 of 2 : SP_2019_RD0349_205_4_20190311_00004.jpg

LM Start	0.01	Rating **	U	Issue No.	4
LM End	0.01	Issue Type +	En	Location *	WS
Category	Earthen Levee			GPS Latitude/Longitude	
				Start	End
Item	Encroachments			38.304870 °	38.304870 °
				121.574730 °	121.574730 °
DWR ID	DWR_RD0349_02_s_2012_4				
Comment Code					
BU : Building					
Inspector Comment					
This encroachment is along the waterward shoulder and was not authorized by the CVFPB. There are multiple encroachments at this site. Owner was working with CVFPB to get permits as of 11-2013. This issue is still pending as of 2016. No change. 5-2017.

Unauthorized building waterside shoulder; Unit 2 Sutter Slough.

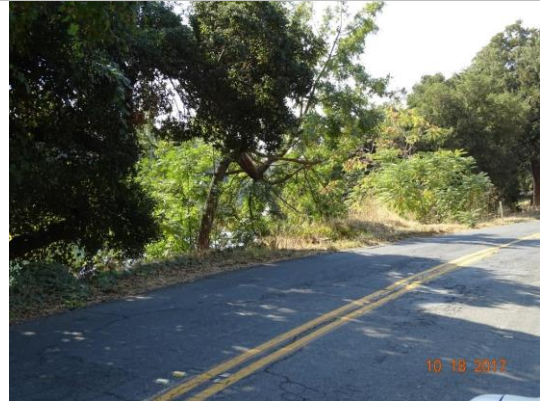
Photo 1 of 1 : SP_2019_RD0349_205_44_20190311_00035.jpg

LM Start	0.04	Rating **	M	Issue No.	44
LM End	0.08	Issue Type +	Ma	Location *	WS
Category	Earthen Levee			GPS Latitude/Longitude	
				Start	End
Item	Vegetation			38.304877 °	38.304719 °
				-121.575384 °	-121.576083 °
DWR ID	DWR_RD0349_02_f_2017_44				
Comment Code					
V2 : Remove the wild growth other than native grasses from the levee slopes.					
Inspector Comment					
Waterside vegetation should be removed or thinned to 20 feet from crown to allow inspection and access.

Photo of waterside vegetation

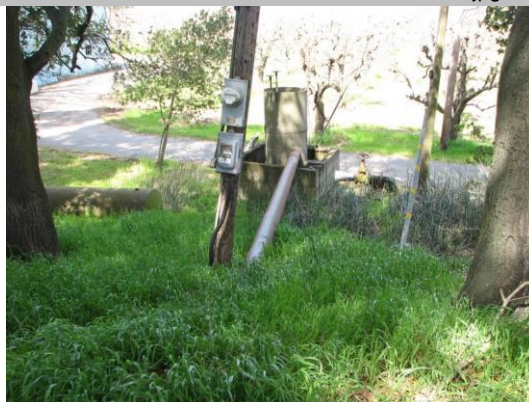
Photo 3 of 3 : UCIP_SP_2019_21576_36591.jpg

Comment Code						
Inspector Comment						
FS_ID:21576 DS_ID:24145 EP_NO: N/A Repair Type: Non-Urgent Crossing Status: Found UCIP Comments: No connection present--need to contact owner to determine if owner plans to use. If crossing is no longer in use owner will need to coordinate with DWR inspector and CVFPB to remove according to Title 23 requirements. Dense vegetation limits the inspector's visibility to identify signs of pipe failure (leaks) along the slope. Recommend removing vegetation along pipe alignment to conduct proper inspection of structure and appurtenances. Unable to determine if crossing is in use. Note date on photos should be 3/18/09 not 7/26/08 camera metadata is incorrect. FIELD_STRUCT_DESC: *ABANDONED* 10-inch irrigation pipe through the levee, 6.0 feet below the levee crown. Pump and slide gate are located on the waterside (WS) slope. Concrete pipe riser and distribution box located on the landside (LS) toe. Service pole and anchor on the LS slope. [Additional Reference(s): DWR Levee Log, 2005] FS Date: 3/18/2009

Multiple appurtenances found on landward side-standpipe, electrical pole, valve, concrete distribution box.

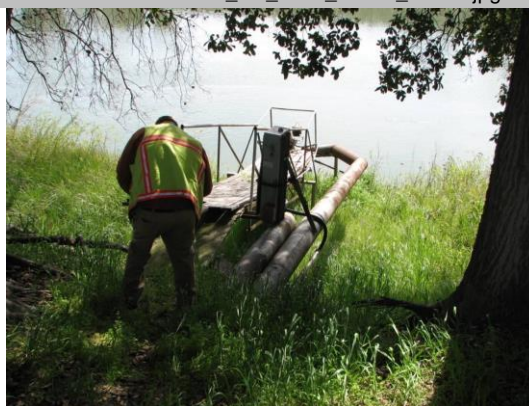
Photo 1 of 3 : UCIP_SP_2019_21577_36597.jpg

Comment Code					
Inspector Comment					
FS_ID:21577 DS_ID:24146 EP_NO: 2480 Repair Type: Non-Urgent Crossing Status: Found UCIP Comments: Dense vegetation limits the inspector's visibility to identify signs of pipe failure (leaks) along the landward slope. Recommend removing vegetation along pipe alignment to conduct proper inspection of structure and appurtenances. Unable to determine if crossing is in use. Note date on photos should be 3/18/09 not 7/26/08 camera metadata is incorrect. FIELD_STRUCT_DESC: 10-inch steel irrigation pipe through the levee, 6.0 feet below the levee crown. Pump and slide gate on the waterside (WS) slope. Concrete pipe riser and distribution box with gate valve located on the landside (LS) toe. Service pole and anchor on the LS slope. (10-inch pipe installed under Permit No. 2480, 1959 - L. C. Peck) [Additional Reference(s): DWR Levee Log, 2005] FS Date: 3/18/2009

Dense vegetation on waterward slope-2 pipes and 1 conduit.

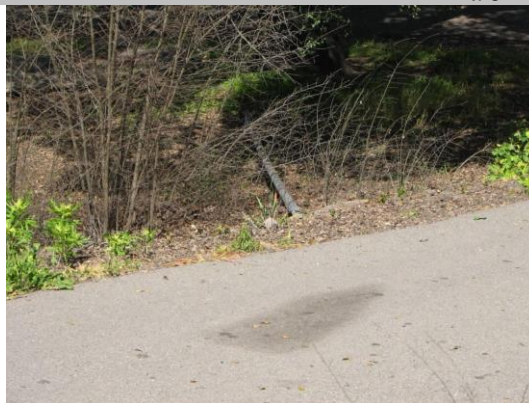
Photo 2 of 3 : UCIP_SP_2019_21613_36687.jpg

Comment Code						
Inspector Comment						
FS_ID:21613 DS_ID:24147 EP_NO: N/A Repair Type: Non-Urgent Crossing Status: Found UCIP Comments: Dense vegetation limits the inspector's visibility to identify signs of pipe failure (leaks) along the slope. Recommend removing vegetation along pipe alignment to conduct proper inspection of structure and appurtenances. Note date on photos should be 3/18/09 not 7/26/08 camera metadata is incorrect. FIELD_STRUCT_DESC: 3-inch steel siphon irrigation pipe through the levee, 3.3 feet below the levee crown. Gate valve on landside (LS). [Additional Reference(s): DWR Levee Log, 2005. USACE Sacramento O&M Manual Unit No. 110, May 1959, revised 29 Dec 2016, (HLM 0.1)] FS Date: 3/18/2009

View of crossing on landward side.

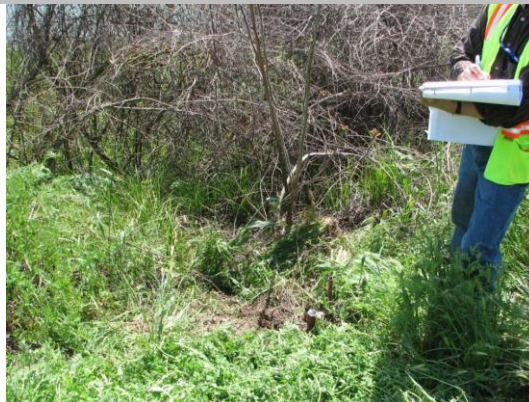
Photo 3 of 3 : UCIP_SP_2019_21613_36688.jpg

View of air valve located on waterward slope--dense vegetation limits inspection.

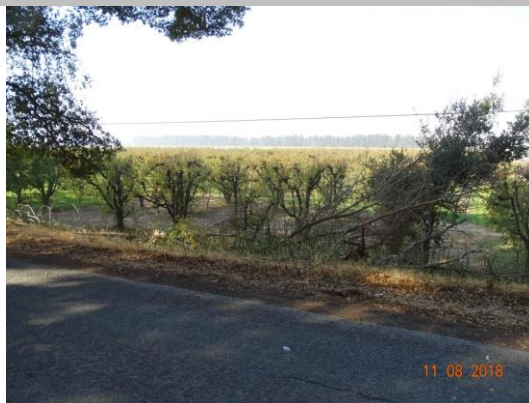
Photo 1 of 1 : SP_2019_RD0349_205_75_20190311_00046.jpg

LM Start	0.25	Rating **	M	Issue No.	75
LM End	0.25	Issue Type +	Ma	Location *	LS
Category	Earthen Levee			GPS Latitude/Longitude	
				Start	End
Item	Encroachments			38.303317 °	38.303317 °
				-121.578673 °	-121.578673 °
DWR ID	DWR_RD0349_02_f_2018_75				
Comment Code					
TR : Tree or limb					
Inspector Comment					
Remove downed tree from the landside slope.

View of downed tree on the landside slope (November 2018).

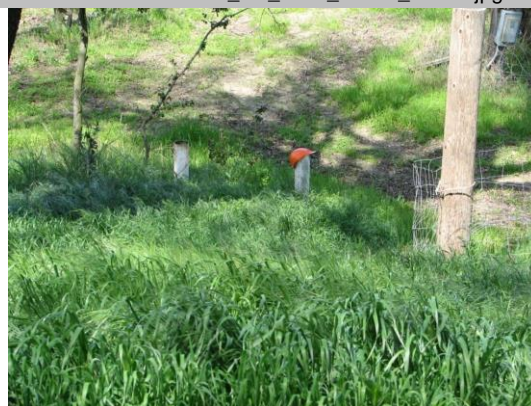
Photo 1 of 3 : UCIP_SP_2019_21614_36691.jpg

Comment Code					
Inspector Comment					
FS_ID:21614 DS_ID:24148 EP_NO: 12006 Repair Type: Non-Urgent Crossing Status: Found UCIP Comments: Altered crossing--contact owner to obtain new permit authoring work. Debris remains on site. Dense vegetation limits the inspector's visibility to identify signs of pipe failure (leaks) along the slope. Recommend removing vegetation along pipe alignment to conduct proper inspection of structure and appurtenances. Note date on photos should be 3/18/09 not 7/26/08 camera metadata is incorrect. FIELD_STRUCT_DESC: 6-inch steel irrigation pipe through the levee, 4 feet below the levee crown. 3-inch conduit through levee to service pump. Steel cutoff wall around pipe at center of levee. Siphon breaker in concrete riser at landside (LS) shoulder. Gate valve on LS. Pump on concrete pad on waterside (WS) slope. Discharge structure at LS toe. (pump with 6-inch pipe authorized under Permit No. 12006, 1977 - Carel Van Loben Sels) [Additional Reference(s): DWR Levee Log, 2005] FS Date: 3/18/2009

View of landward side--unable to inspect.

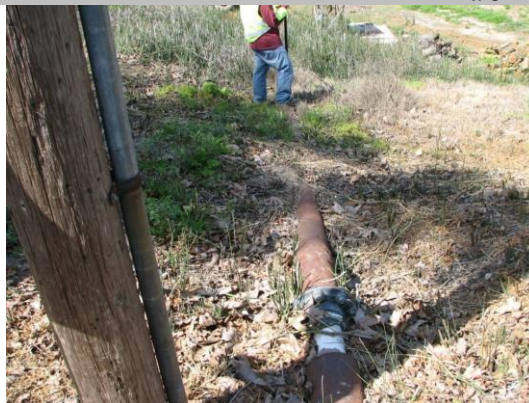
Photo 3 of 3 : UCIP_SP_2019_21615_36696.jpg

Comment Code						
Inspector Comment						
FS_ID:21615 DS_ID:24149 EP_NO: N/A Repair Type: Non-Urgent Crossing Status: Found UCIP Comments: Need to contact owner (Permit No. 3678) to determine if crossing is still in use. If crossing is not in use will need to coordinate with DWR Inspector and CVFPB to remove pipe according to Title 23 requirements. Note date on photos should be 3/18/09 not 7/26/08 camera metadata is incorrect. FIELD_STRUCT_DESC: 6-inch steel irrigation pipe through the levee, 2.5 feet below the crown. Pump on waterside (WS) slope. Service pole at landside (LS) shoulder. 3-inch conduit through levee to service pump. (removed and installed pump, and construction of cement filled steel piling foundation on levee authorized under Permit No. 3678, 1961 - Ostman Bros.) [Additional Reference(s): DWR Levee Log, 2005. USACE Sacramento O&M Manual Unit No. 110, May 1959, revised 29 Dec 2016, (HLM 0.6)] FS Date: 3/18/2009

View of landward side--it appears PVC pipe was sleeved through existing crossing.

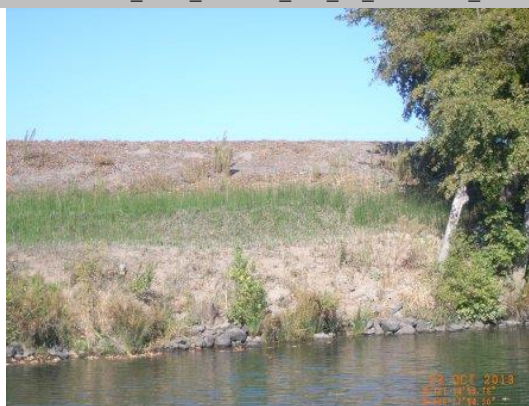
Photo 1 of 1 : SP_2019_RD0349_205_28_20190311_00013.jpg

LM Start	0.60	Rating **	M	Issue No.	28
LM End	0.72	Issue Type +	Ma	Location *	WS
Category	Supplemental			GPS Latitude/Longitude	
				Start	End
Item	2017 USACE Erosion Survey, DRAFT			38.298897 °	38.297384 °
				-121.581571 °	-121.582176 °
DWR ID	DWR_RD0349_02_f_2018_28				
Comment Code					
Inspector Comment					
2017 Site ID: STM 25.5 R					
Status: Eroding					
2017 Field Notes: No observed change.					
Site History: 2010 - Small maintenance, erosion into the toe. 2011 - Minor new erosion at toe. 2015 - Minor new erosion at toe, new tree pop-out. 2016 - Fresh scarp at downstream end.

USACE 2013 Photo #1

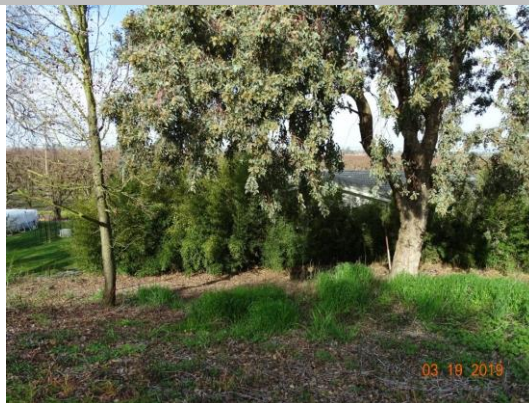
Photo 1 of 1 : SP_2019_RD0349_205_63_20190320_00107.jpg

LM Start	1.00	Rating **	U	Issue No.	63
LM End	1.03	Issue Type +	En	Location *	LS
Category	Earthen Levee			GPS Latitude/Longitude	
				Start	End
Item	Vegetation			38.293467 °	38.292930 °
				-121.583548 °	-121.583702 °
DWR ID	DWR_RD0349_02_s_2019_63				
Comment Code					
V6 : Landscaping					
Inspector Comment					
Landscaping is blocking view of the landside toe

View of landscaping on the landside slope (Spring 2019).

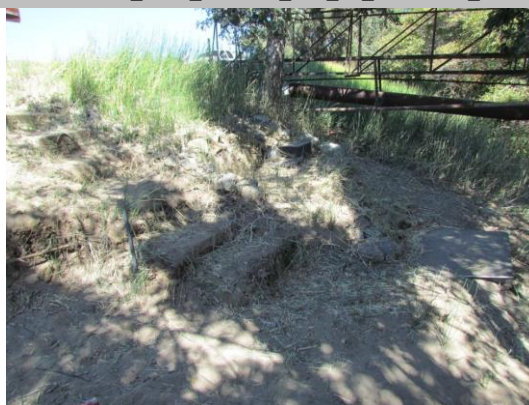
Photo 2 of 2 : SP_2019_RD0349_205_36_20190311_00021.jpg

Landowner has knotted step into the waterside slope

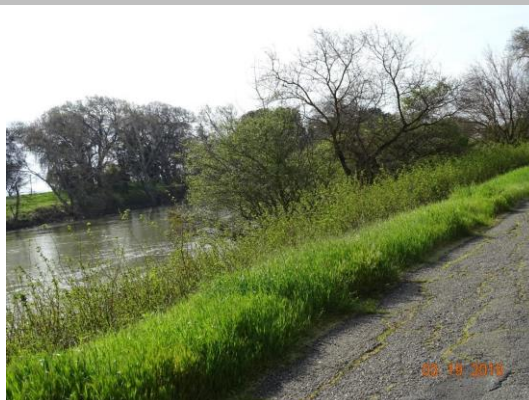
Photo 1 of 1 : SP_2019_RD0349_205_79_20190320_00108.jpg

LM Start	1.15	Rating **	U	Issue No.	79
LM End	1.18	Issue Type +	Ma	Location *	WS
Category	Earthen Levee			GPS Latitude/Longitude	
				Start	End
Item	Vegetation			38.291302 °	38.290855 °
				-121.584145 °	-121.584142 °
DWR ID	DWR_RD0349_02_s_2019_79				
Comment Code					
V2 : Remove the wild growth other than native grasses from the levee slopes.					
Inspector Comment					
Wild growth is blocking the view of waterside slope.

View looking downstream of wild growth on the waterside slope (Spring 2019).

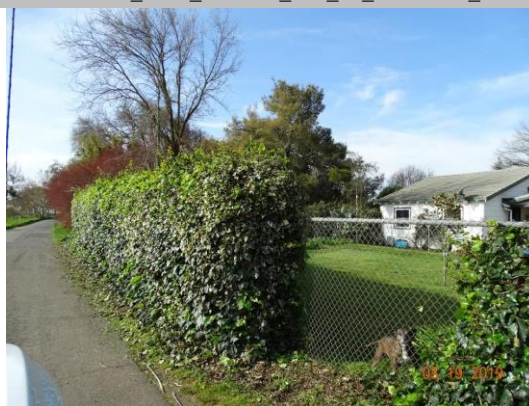
Photo 1 of 1 : SP_2019_RD0349_205_82_20190320_00109.jpg

LM Start	1.31	Rating **	M	Issue No.	82
LM End	1.33	Issue Type +	En	Location *	LS
Category	Earthen Levee			GPS Latitude/Longitude	
				Start	End
Item	Encroachments			38.288917 °	38.288665 °
				-121.584030 °	-121.584022 °
DWR ID	DWR_RD0349_02_s_2019_82				
Comment Code					
FE : Fence					
Inspector Comment					
Chainlink fence is located on the landside shoulder.

View looking downstream at chainlink fence on the landside shoulder (Spring 2019).

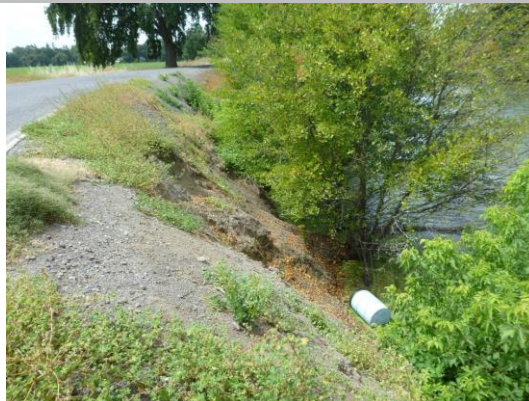
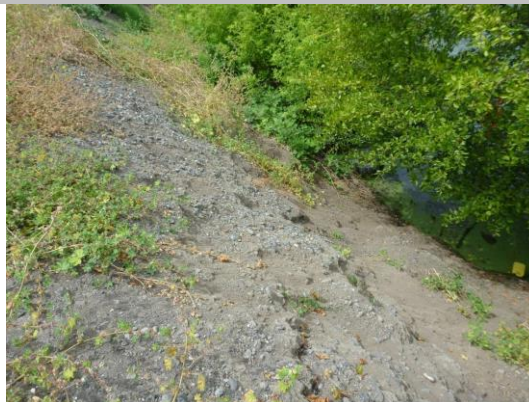
LM Start	1.33	Rating **	M	Issue No.	40
LM End	1.49	Issue Type +	Ma	Location *	
Category	Supplemental			GPS Latitude/Longitude	
				Start	End
Item	2017 Storm Damage			38.288727 °	38.286475 °
				-121.583823 °	-121.585026 °
DWR ID	DWR_RD0349_02_f_2017_40				
Comment Code					
Inspector Comment					
Levee Evaluation Comments					
Description:					
Site ID No:66					
Site Designation:DWR_RD0349_02_s_2012_28					
Repair Type: Erosion					
Rating:Area of Concern					
Field Date:6/7/2017					
Notes: dense vegetation and large trees hindered visibility; slope riprap appeared failing in some parts

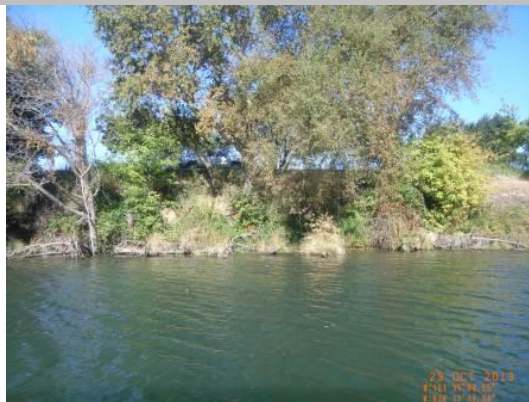
Photo 1 of 1 : SP_2019_RD0349_205_27_20190311_00012.jpg

Comment Code					
Inspector Comment					
2017 Site ID: STM 24.7 R					
Status: Critical					
2017 Field Notes: No observed change.					
Site History: 1997 - Erosion of very sandy levee behind large stand of riparian vegetation on top right bank. Dry ravel of sand. 1999 - Quarry waste rock was dumped down the levee slope; poor repair job; still eroding in places. Eroding at midslope off fabric. 2005 - Length revised, only the middle 150 - 200 ft are eroding. 2006 - Some rock/small material dumped down the bank but it is slowly unraveling. Upstream end is unraveling faster. Steep slope with poor gradation so fines are washing out. 2010 - Lots of overhanging trees and erosion pockets. 2011 - This site is upgraded to CRITICAL. Near vertical bank at the downstream end. New erosion at various locations throughout the site.

USACE 2013 Photo #1

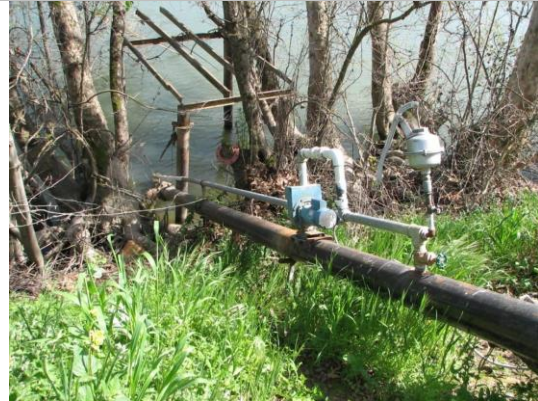
Photo 1 of 3 : UCIP_SP_2019_21606_36655.jpg

Comment Code						
Inspector Comment						
FS_ID:21606 DS_ID:24154 EP_NO: 6274 Repair Type: Non-Urgent Crossing Status: Found UCIP Comments: Crossing appears to have been altered--recommend coordinating with owner to determine records for crossing. Will need permit issued for pipe install. Dense vegetation limits the inspector's visibility to identify signs of pipe failure (leaks) along the slope. Recommend removing vegetation along pipe alignment to conduct proper inspection of structure and appurtenances. Note date on photos should be 3/18/09 not 7/26/08 camera metadata is incorrect. FIELD_STRUCT_DESC: 12-inch steel irrigation pipe through the levee, 3 feet below the crown. Cutoff wall around pipe at waterside (WS) shoulder. Siphon breaker at landside (LS) shoulder. Air vent and pressure breaker on WS slope. Slant pump on the WS slope. Concrete distribution box at LS toe. (12-inch pipe and slant mounted pump installed and existing 8-inch pipe removed under Permit No. 6274, 1974 - P. L. Peck) [Additional Reference(s): DWR Levee Log, 2005] FS Date: 3/18/2009

View of abandoned framing located on river's edge.

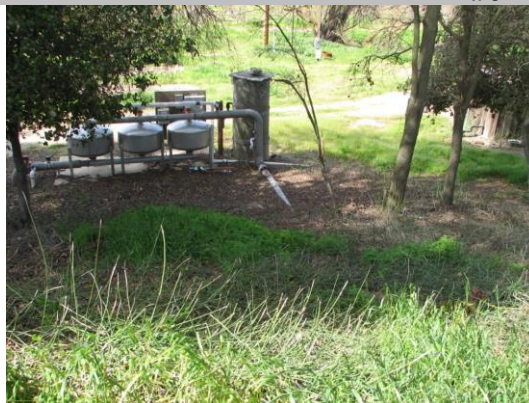
Photo 3 of 3 : UCIP_SP_2019_21607_36658.jpg

Comment Code					
Inspector Comment					
FS_ID:21607 DS_ID:24155 EP_NO: 1116 Repair Type: Non-Urgent Crossing Status: Found UCIP Comments: Dense vegetation limits the inspector's visibility to identify signs of pipe failure (leaks) along the landward slope. Recommend removing vegetation along pipe alignment to conduct proper inspection of structure and appurtenances. Note date on photos should be 3/18/09 not 7/26/08 camera metadata is incorrect. FIELD_STRUCT_DESC: 8-inch steel irrigation pipe through the levee, 4.7 feet below the levee crown. Two concrete cutoff walls under each shoulder. Pressure breaker in concrete riser at levee shoulder. Pump on waterside (WS). (8-inch pipe authorized under Permit No. 1116, 1974 - A. C. Ostman). [Additional Reference(s): DWR Levee Log, 2005. USACE Sacramento O&M Manual Unit No. 110, May 1959, revised 29 Dec 2016, (HLM 1.7)] FS Date: 3/18/2009

Filter system, control panel, and stand pipe located at the landward toe.

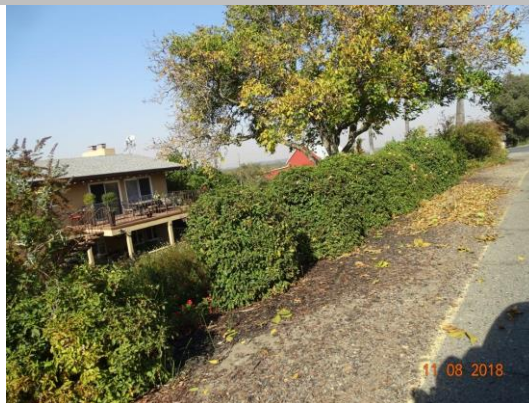
Photo 1 of 1 : SP_2019_RD0349_205_66_20190311_00044.jpg

LM Start	1.75	Rating **	M	Issue No.	66
LM End	1.75	Issue Type +	En	Location *	LS
Category	Earthen Levee			GPS Latitude/Longitude	
				Start	End
Item	Vegetation			38.284205 °	38.284205 °
				-121.588760 °	-121.588760 °
DWR ID	DWR_RD0349_02_f_2018_66				
Comment Code					
V6 : Landscaping					
Inspector Comment

View looking downstream at landscaping on the landside shoulder (November 2018).

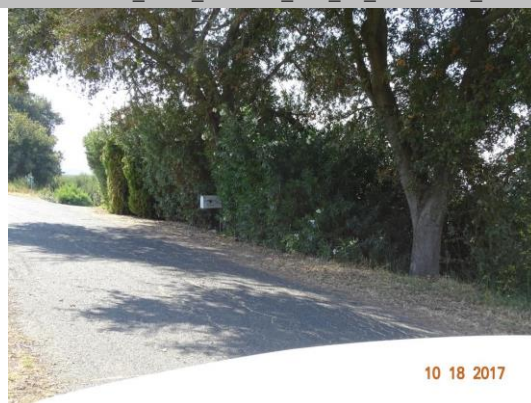
Photo 1 of 1 : SP_2019_RD0349_205_58_20190311_00038.jpg

LM Start	1.80	Rating **	U	Issue No.	58
LM End	1.80	Issue Type +	En	Location *	LS
Category	Earthen Levee			GPS Latitude/Longitude	
				Start	End
Item	Vegetation			38.283642 °	38.283642 °
				-121.589158 °	-121.589158 °
DWR ID	DWR_RD0349_02_f_2017_58				
Comment Code					
V6 : Landscaping					
Inspector Comment					
Landside landscaping should be thinned and maintained to allow inspection and access to levee slope and toe.

View of landside landscaping on the levee slope and toe

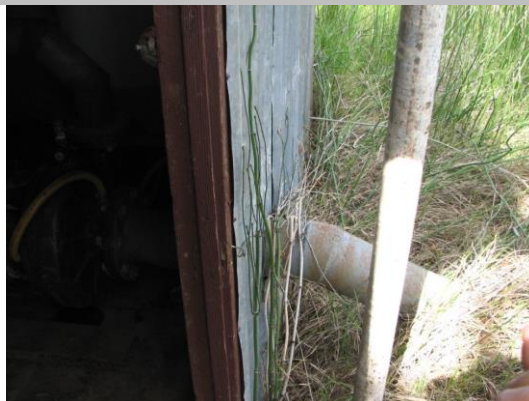
Photo 2 of 3 : UCIP_SP_2019_21608_36663.jpg

View of pipe daylight at shed on waterward side.

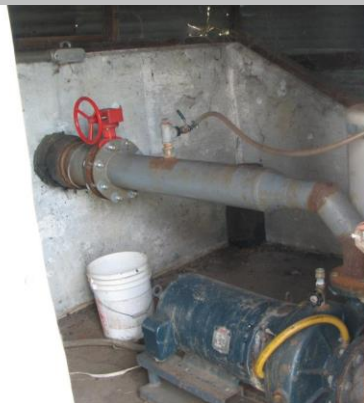
Photo 3 of 3 : UCIP_SP_2019_21608_36665.jpg

Comment Code						
Inspector Comment						
FS_ID:21608 DS_ID:24156 EP_NO: N/A Repair Type: Non-Urgent Crossing Status: Found UCIP Comments: Dense vegetation limits the inspector's visibility to identify signs of pipe failure (leaks) along the slope. Recommend removing vegetation along pipe alignment to conduct proper inspection of structure and appurtenances. Note date on photos should be 3/18/09 not 7/26/08 camera metadata is incorrect. FIELD_STRUCT_DESC: 10-inch steel irrigation pipe through the levee, 3.9 feet below the levee crown. Siphon breaker in concrete riser on the landside (LS) shoulder. Pump and gate valve in pump house on the waterside (WS) slope. [Additional Reference(s): DWR Levee Log, 2005. USACE Sacramento O&M Manual Unit No. 110, May 1959, revised 29 Dec 2016, (HLM 1.9)] FS Date: 3/18/2009

View inside pump house of pipe crossing coming out of levee.

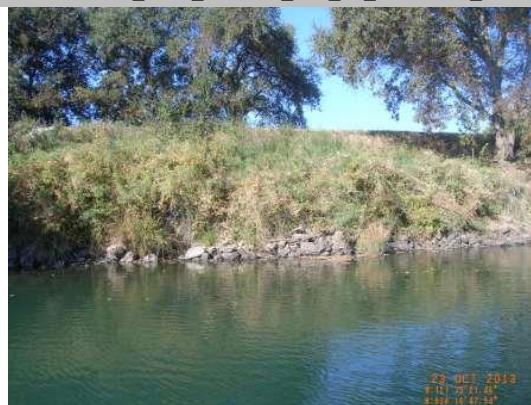
Photo 1 of 1 : SP_2019_RD0349_205_26_20190311_00011.jpg

LM Start	2.04	Rating **	M	Issue No.	26
LM End	2.05	Issue Type +	Ma	Location *	WS
Category	Supplemental			GPS Latitude/Longitude	
				Start	End
Item	2017 USACE Erosion Survey, DRAFT			38.280069 °	38.279919 °
				-121.589443 °	-121.589438 °
DWR ID	DWR_RD0349_02_f_2018_26				
Comment Code					
Inspector Comment					
2017 Site ID: STM 24.1 R					
Status: Eroding					
2017 Field Notes: No observed change.					
Site History: 2011 - Small scallop caused by erosion and wave wash.

USACE 2013 Photo #1

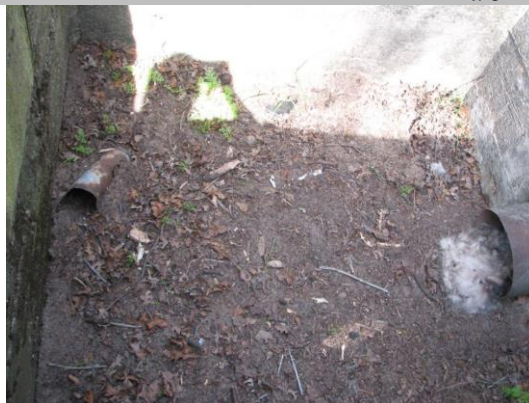
Photo 1 of 3 : UCIP_SP_2019_21609_36668.jpg

Comment Code					
Inspector Comment					
FS_ID:21609 DS_ID:24157 EP_NO: N/A Repair Type: Non-Urgent Crossing Status: Found UCIP Comments: Debris scattered--need to contact owner. If crossing is not in used will need to coordinate with DWR Inspector and CVFPB to remove per Title 23 requirements. Dense vegetation limits the inspector's visibility to identify signs of pipe failure (leaks) along the slope. Recommend removing vegetation along pipe alignment to conduct proper inspection of structure and appurtenances. Note date on photos should be 3/18/09 not 7/26/08 camera metadata is incorrect. FIELD_STRUCT_DESC: 8-inch irrigation pipe of unknown material sleeved through 12-inch pipe through the levee, 4 feet below the levee crown. Annular gap not grouted. Service pole on the waterside (WS) shoulder. Pump on the WS. Concrete distribution box at landside (LS) toe. [Additional Reference(s): DWR Levee Log, 2005. USACE Sacramento O&M Manual Unit No. 110, May 1959, revised 29 Dec 2016, (HLM 2.3), 12-inch] FS Date: 3/18/2009

Inside view of distribution box located on landward side.

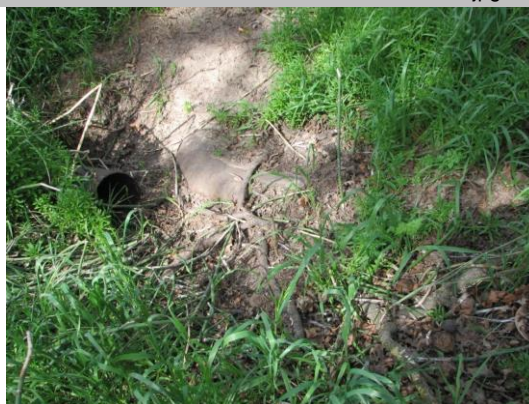
Photo 2 of 3 : UCIP_SP_2019_21609_36667.jpg

Debris along pipe alignment.

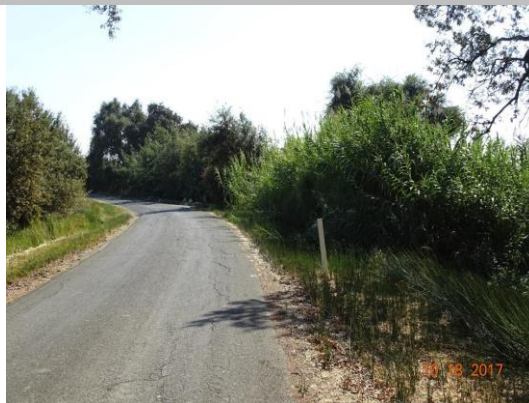
Photo 2 of 2 : SP_2019_RD0349_205_60_20190311_00040.jpg

LM Start	2.37	Rating **	M	Issue No.	60 (cont)
LM End	2.44	Issue Type +	Ma	Location *	LS

View of arundo and other vegetation on landside slope

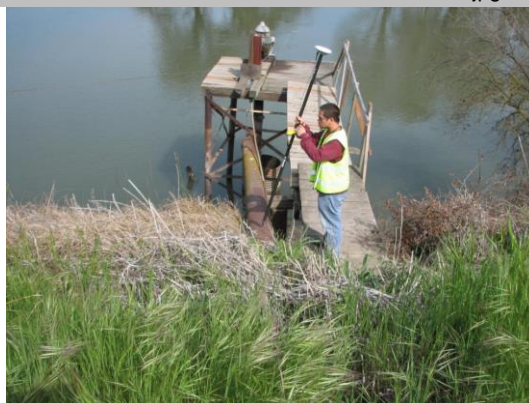
Photo 2 of 3 : UCIP_SP_2019_39873_36676.jpg

Overview of waterward side--dense vegetation limits slope inspection.

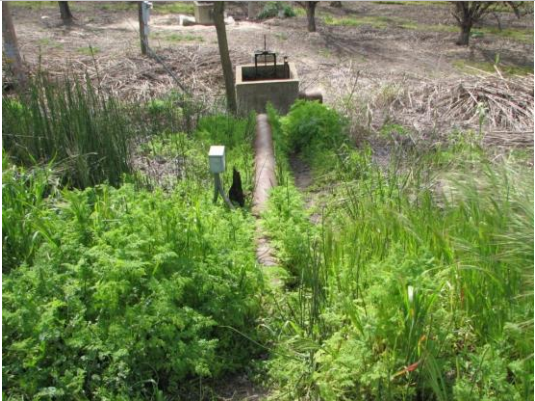
Photo 3 of 3 : UCIP_SP_2019_39873_36673.jpg

View of landward side--2 distribution boxes are located along pipe alignment.

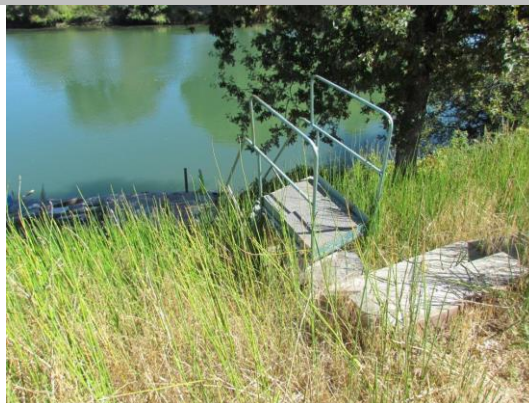
Photo 1 of 3 : SP_2019_RD0349_205_1_20190311_00001.jpg

LM Start	2.39	Rating **	U	Issue No.	1
LM End	2.39	Issue Type +	En	Location *	WS
Category	Earthen Levee			GPS Latitude/Longitude	
				Start	End
Item	Encroachments			38.275403 °	38.275403 °
				-121.591229 °	-121.591229 °
DWR ID	DWR_RD0349_02_f_2013_1				
Comment Code					
ST : Stairway					
Inspector Comment					
The landowner has installed steps on the waterside slope and has an unauthorized boat dock anchored to the waterside slope.

Unauthorized metal steps on the waterside levee slope at levee mile 2.39.

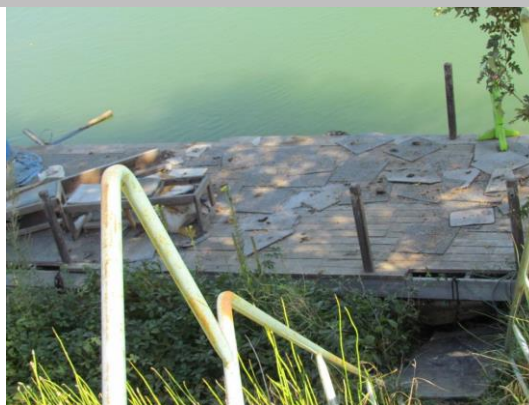
Photo 2 of 3 : SP_2019_RD0349_205_1_20190311_00002.jpg

Unauthorized dock at waterside toe.

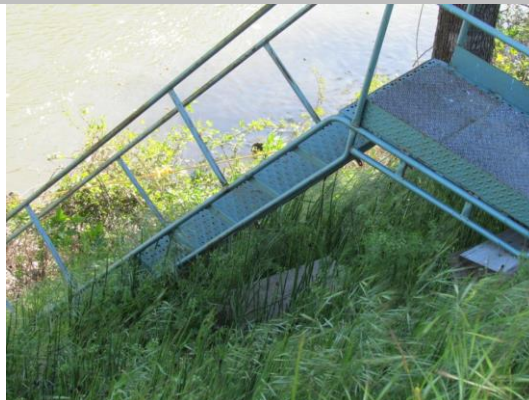
Photo 3 of 3 : SP_2019_RD0349_205_1_20190311_00003.jpg

Unauthorized metal steps on the waterside slope levee mile 2.39.

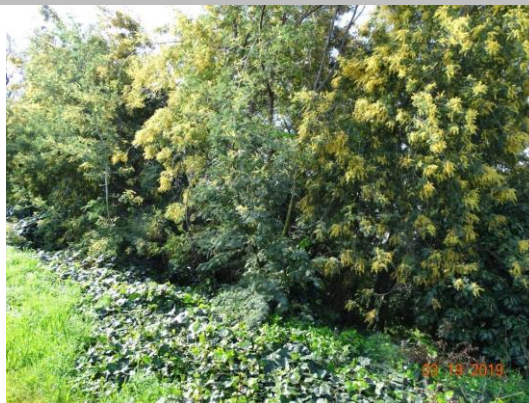
Photo 1 of 1 : SP_2019_RD0349_205_93_20190320_00113.jpg

LM Start	2.41	Rating **	U	Issue No.	93
LM End	2.43	Issue Type +	En	Location *	LS
Category	Earthen Levee			GPS Latitude/Longitude	
				Start	End
Item	Vegetation			38.275242 °	38.274987 °
				-121.591000 °	-121.590630 °
DWR ID	DWR_RD0349_02_s_2019_93				
Comment Code					
V6 : Landscaping					
Inspector Comment					
Landscaping is blocking the view down the landside slope.

View of landscaping on the landside shoulder (Spring 2019).

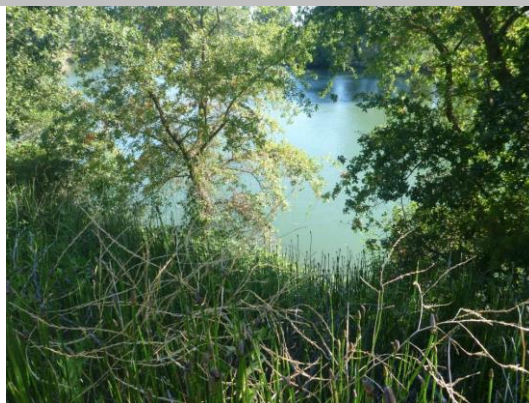
Photo 1 of 2 : SP_2019_RD0349_205_42_20190311_00030.jpg

LM Start	2.43	Rating **	A/W	Issue No.	42
LM End	2.44	Issue Type +	Ma	Location *	
Category	Supplemental			GPS Latitude/Longitude	
				Start	End
Item	2017 Storm Damage			38.275131 °	38.275036 °
				-121.590594 °	-121.590461 °
DWR ID	DWR_RD0349_02_f _ 2017_42				
Comment Code					
Inspector Comment					
Levee Evaluation Comments					
Description:District Station 128+76 to 129+27, Sec. 13, T. 5 N. R. 3 E., M.D.M. Approximately 51 linear feet of erosion exists along the water side slope of Steamboat Slough (Unit 2). The erosion area commences approximately 3/4 of the way down the slope from the levee crown and extends to the waterside toe around existing trees. No rip rap is visible in this area.					
Site ID No:325					
Site Designation:LMA-152					
Repair Type: Erosion					
Rating:Area of Concern					
Field Date:7/28/2017					
Notes: access very difficult, steep slope, dense brush

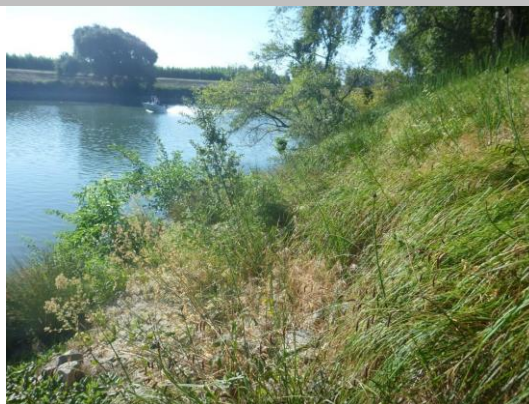
Photo 1 of 3 : SP_2019_RD0349_205_43_20190311_00032.jpg

LM Start	2.56	Rating **	A/W	Issue No.	43
LM End	2.59	Issue Type +	Ma	Location *	
Category	Supplemental			GPS Latitude/Longitude	
				Start	End
Item	2017 Storm Damage			38.273769 °	38.273386 °
				-121.588742 °	-121.588672 °
DWR ID	DWR_RD0349_02_f_2017_43				
Comment Code					
Inspector Comment					
Levee Evaluation Comments					
Description: District Station 135+81 to 137+00, Sec. 13, T. 5 N. R. 3 E., M.D.M. Approximately 119 linear feet of sloughing exists due to scour along the water side toe of Steamboat Slough (Unit 2). The erosion area commences approximately 3/4 of the way down the slope from the levee crown and extends to the waterside toe. No rip rap is visible in this area.					
Site ID No: 326					
Site Designation: LMA-153					
Repair Type: Erosion					
Rating: Area of Concern					
Field Date: 7/28/2017					
Notes: no berm

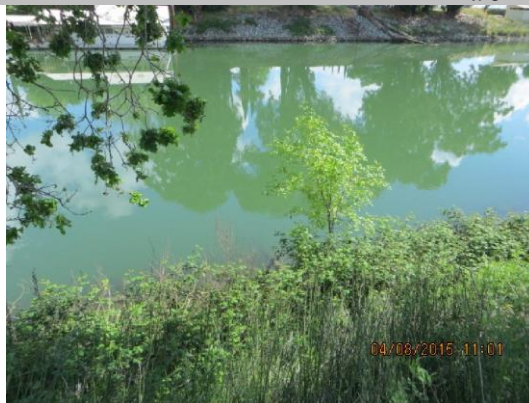
Photo 1 of 3 : UCIP_SP_2019_44328_73707.jpg

LM Start	2.93	Rating **	M	Issue No.	117	
LM End	2.93	Issue Type +	En	Location *		
Category	Supplemental			GPS Latitude/Longitude		
				Start	End	
Item	DWR UCIP Field Study			38.268674 °	38.268674 °	
				-121.589419 °	-121.589419 °	
DWR ID	24159					
Comment Code						
Inspector Comment						
FS_ID:44328						
DS_ID:24159						
EP_NO: N/A						
Repair Type: Non-Urgent						
Crossing Status: Found						
UCIP Comments: Pipe appears abandoned and should be done so properly.						
FIELD_STRUCT_DESC: *ABANDONED* 6-inch irrigation pipe of						
unknown material through the levee, 1.5 feet below the levee crown.						
[Additional Reference(s): DWR Levee Log, 2005. USACE Sacramento						
O&M Manual Unit No. 110, May 1959, revised 29 Dec 2016, (HLM 3.1)]						
FS Date: 4/8/2015

Pipe visible in water at WS toe.

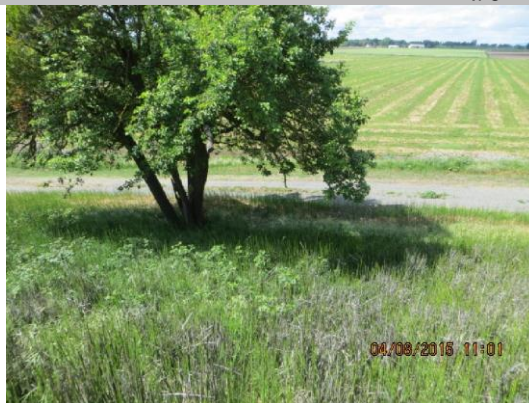
Photo 3 of 3 : UCIP_SP_2019_44328_73705.jpg

LM Start	2.93	Rating **	M	Issue No.	117 (cont)	
LM End	2.93	Issue Type +	En	Location *		
Category	Supplemental			GPS Latitude/Longitude		
				Start	End	
Item	DWR UCIP Field Study			38.268674 °	38.268674 °	
				-121.589419 °	-121.589419 °	
DWR ID	24159					
Comment Code						
Inspector Comment						
FS_ID:44328						
DS_ID:24159						
EP_NO: N/A						
Repair Type: Non-Urgent						
Crossing Status: Found						
UCIP Comments: Pipe appears abandoned and should be done so properly.						
FIELD_STRUCT_DESC: *ABANDONED* 6-inch irrigation pipe of						
unknown material through the levee, 1.5 feet below the levee crown.						
[Additional Reference(s): DWR Levee Log, 2005. USACE Sacramento						
O&M Manual Unit No. 110, May 1959, revised 29 Dec 2016, (HLM 3.1)]						
FS Date: 4/8/2015

No pipe visible on LS toe.

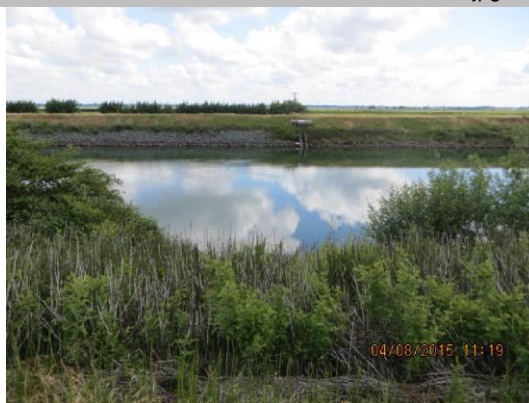
Photo 2 of 3 : UCIP_SP_2019_46172_74554.jpg

LM Start	3.15	Rating **	M	Issue No.	120
LM End	3.15	Issue Type +	En	Location *	
Category	Supplemental			GPS Latitude/Longitude	
				Start	End
Item	DWR UCIP Field Study			38.265608 °	38.265608 °
				-121.588391 °	-121.588391 °
DWR ID	25099				
Comment Code					
Inspector Comment					
FS_ID:46172					
DS_ID:25099					
EP_NO: N/A					
Repair Type: Non-Urgent					
Crossing Status: Found					
UCIP Comments: Appears abandoned and if so should be verified as having been done so properly.					
FIELD_STRUCT_DESC: *ABANDONED* 6-inch pipe of unknown material or purpose through the levee, 4.5 feet below the levee crown.					
Service pole at landside (LS) toe.					
FS Date: 4/2/2015

View of WS from shoulder at crossing. Pipe not found on WS.

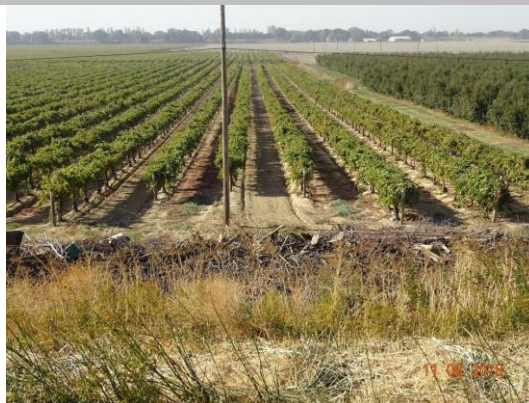
Photo 1 of 1 : SP_2019_RD0349_205_81_20190311_00049.jpg

LM Start	3.18	Rating **	M	Issue No.	81
LM End	3.18	Issue Type +	En	Location *	WS
Category	Earthen Levee			GPS Latitude/Longitude	
				Start	End
Item	Encroachments			38.265185 °	38.265185 °
				-121.588426 °	-121.588426 °
DWR ID	DWR_RD0349_02_s_2018_81				
Comment Code					
PR : Prunings					
Inspector Comment					
Remove prunings from the landside toe.

View of prunings on the landside toe (November 2018).

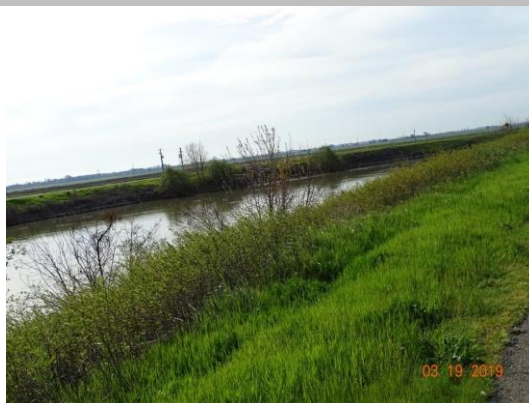
Photo 1 of 1 : SP_2019_RD0349_205_102_20190320_00115.jpg

LM Start	3.24	Rating **	U	Issue No.	102
LM End	3.28	Issue Type +	Ma	Location *	WS
Category	Earthen Levee			GPS Latitude/Longitude	
				Start	End
Item	Vegetation			38.264312 °	38.263712 °
				-121.588480 °	-121.588557 °
DWR ID	DWR_RD0349_02_s_2019_102				
Comment Code					
V2 : Remove the wild growth other than native grasses from the levee slopes.					
Inspector Comment					
Wild growth is blocking the view down waterside slope.

View looking downstream at wild growth on the waterside slope (Spring 2019).

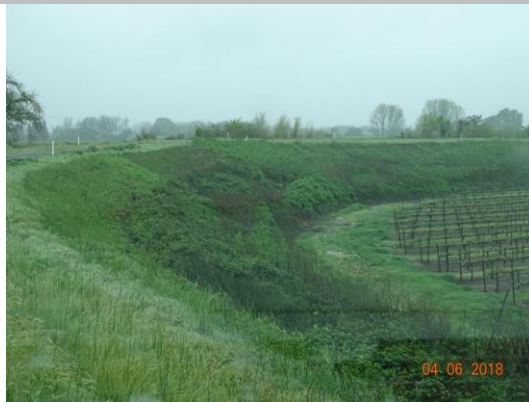
Photo 1 of 1 : SP_2019_RD0349_205_62_20190311_00042.jpg

LM Start	3.29	Rating **	M	Issue No.	62
LM End	3.60	Issue Type +	Ma	Location *	LS
Category	Earthen Levee			GPS Latitude/Longitude	
				Start	End
Item	Vegetation			38.263594 °	38.262449 °
				-121.588629 °	-121.593726 °
DWR ID	DWR_RD0349_02_f_2018_62				
Comment Code					
V9 : Keep the crown roadway free of vegetation.					
Inspector Comment					
Remove thick berry vines that completely block inspection and access to toe.

View of berry vines

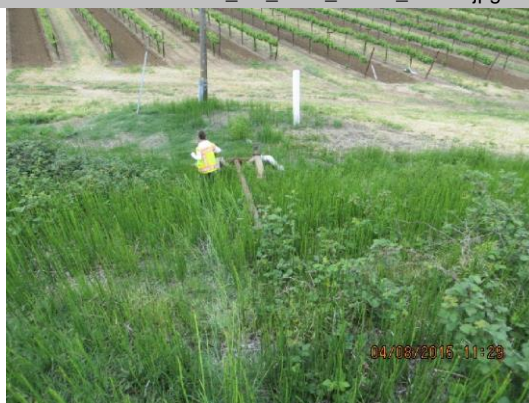
Photo 1 of 3 : UCIP_SP_2019_44333_73713.jpg

LM Start	3.31	Rating **	M	Issue No.	121
LM End	3.31	Issue Type +	En	Location *	
Category	Supplemental			GPS Latitude/Longitude	
				Start	End
Item	DWR UCIP Field Study			38.263359 °	38.263359 °
				-121.588721 °	-121.588721 °
DWR ID	24161				
Comment Code					
Inspector Comment					
FS_ID:44333					
DS_ID:24161					
EP_NO: N/A					
Repair Type: Non-Urgent					
Crossing Status: Found					
UCIP Comments: Pipe appears abandoned and if so should be done so properly.					
FIELD_STRUCT_DESC: *ABANDONED* 6-inch irrigation pipe of unknown material through the levee, 4.5 feet below the crown. Pump and switch panel located on the waterside (WS) slope. Service pole and concrete distribution box at landside (LS) toe. [Additional Reference(s): DWR Levee Log, 2005. USACE Sacramento O&M Manual Unit No. 110, May 1959, revised 29 Dec 2016, (HLM 3.5)]					
FS Date: 4/8/2015

Pipe, distribution box, and power pole visible on LS slope/toe.

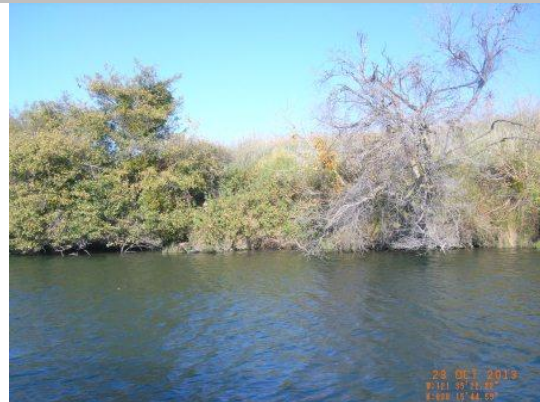
Photo 1 of 1 : SP_2019_RD0349_205_23_20190311_00007.jpg

LM Start	3.38	Rating **	M	Issue No.	23
LM End	3.49	Issue Type +	Ma	Location *	WS
Category	Supplemental			GPS Latitude/Longitude	
				Start	End
Item	2017 USACE Erosion Survey, DRAFT			38.262510 °	38.262533 °
				-121.589481 °	-121.591690 °
DWR ID	DWR_RD0349_02_f_2018_23				
Comment Code					
Inspector Comment					
2017 Site ID: STM 22.8 R					
Status: Eroding					
2017 Field Notes: No observed change.					
Site History: 2010 - Slumping sections on the lower bank, appears to be scouring around the trees. 2011 - Soil beach at toe.

USACE 2013 Photo #1

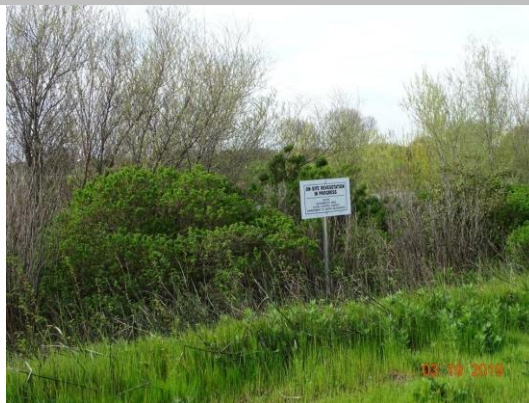
Photo 1 of 1 : SP_2019_RD0349_205_103_20190320_00116.jpg

LM Start	3.50	Rating **	A/W	Issue No.	103
LM End	3.57	Issue Type +	Ob	Location *	WS
Category	Earthen Levee			GPS Latitude/Longitude	
				Start	End
Item	Vegetation			38.262743 °	38.262620 °
				-121.591877 °	-121.593085 °
DWR ID	DWR_RD0349_02_s_2019_103				
Comment Code					
V8 : Environmental Requirements.					
Inspector Comment					
Revegetation site

View of revegetation site sign (Spring 2019).
